Steve Jones
1989 928 S4 Stone Grey Metallic Auto
Bizman928@hotmail.co.uk

Windscreen Wiper Motor Repair

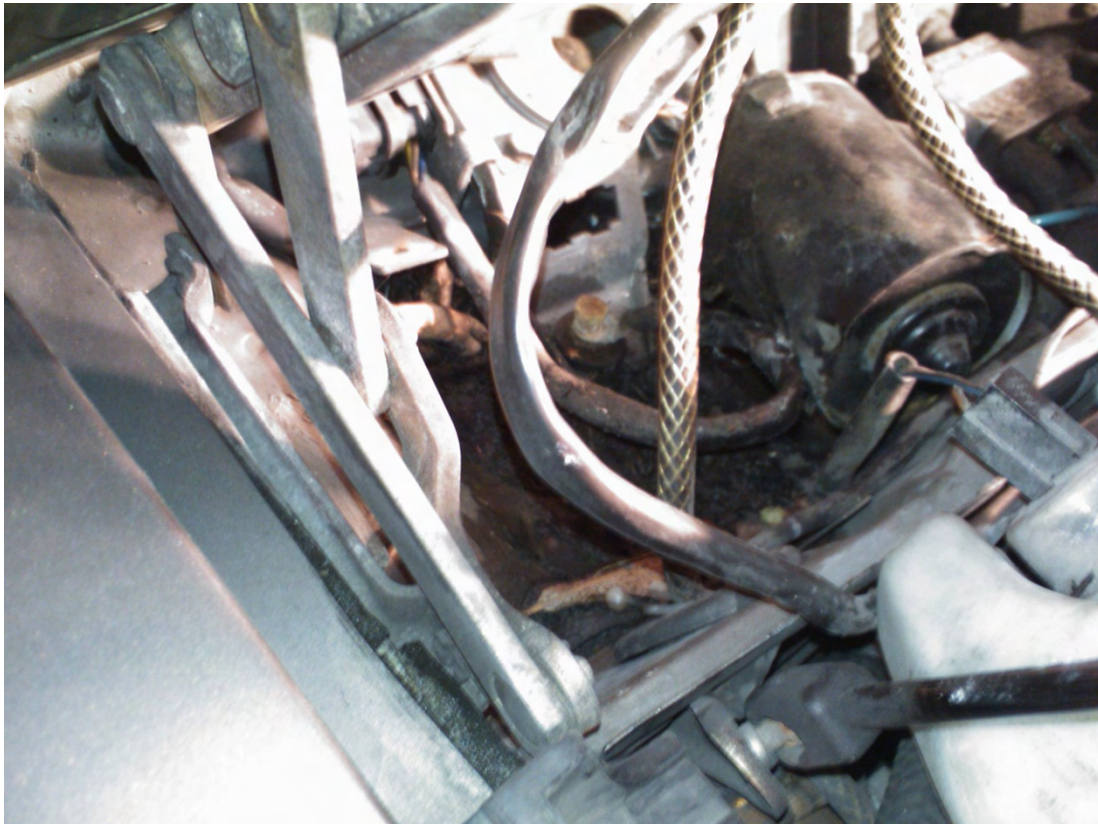
I removed the plastic weather cover above the bulkhead with the bonnet up. This showed the "concentrated washer bottle in the way, so that got its locating bolt unscrewed and then a "slide the right" & "hey presto" off that came – sliding the washer motor out of the centre of the bottle as it came. I removed the but holding the wiper linkage to the shaft of the motor as I wanted to isolate the problem – trapped linkage or seized motor? With the linkage split from the motor, the wipers could move freely but the motor spindle was locked solid! The motor is the problem!

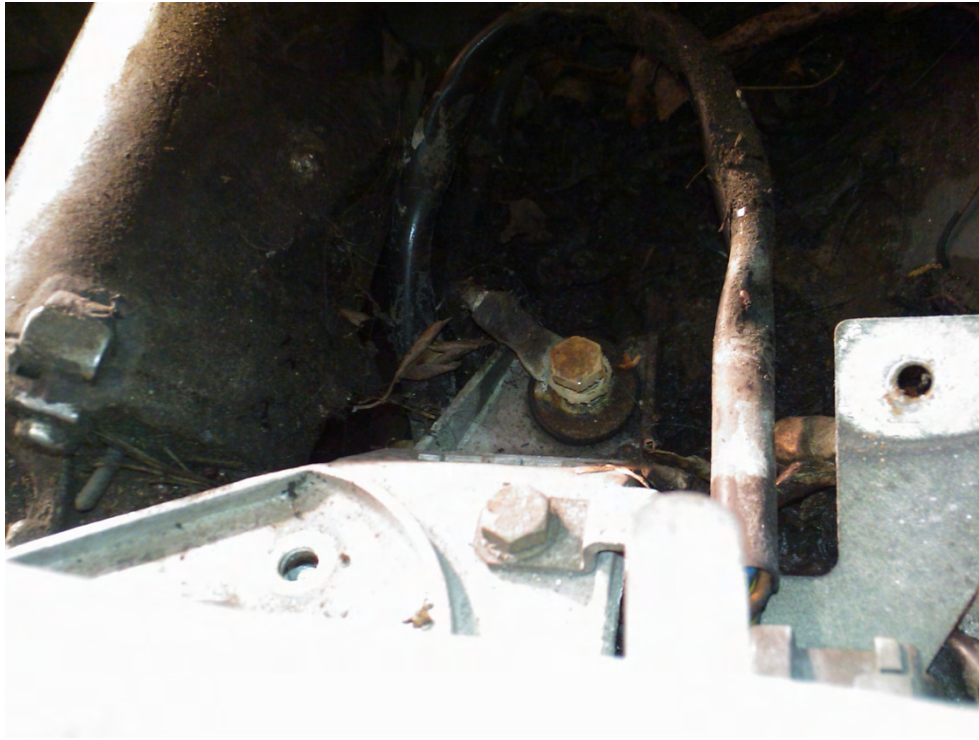
So, to the task of removing the wiper motor from the 928. I removed the wipers, wiper cover trim which bolts across both wipers and across the wings to the small screw at either outer edge under the glass vertical cover strips. All removed & placed carefully on the floor for fear of damage. I then removed the 3 x 10mm bolts holding the motor to the linkage frame and undid the double plug on the left side of the linkage so the motor could be free to remove. The motor was stuck, trapped by the linkage – See the photo. I had to remove the single 10mm bolt at the base of the linkage that also holds the earth wire to the motor to facilitate the motor removal. [See Photo]

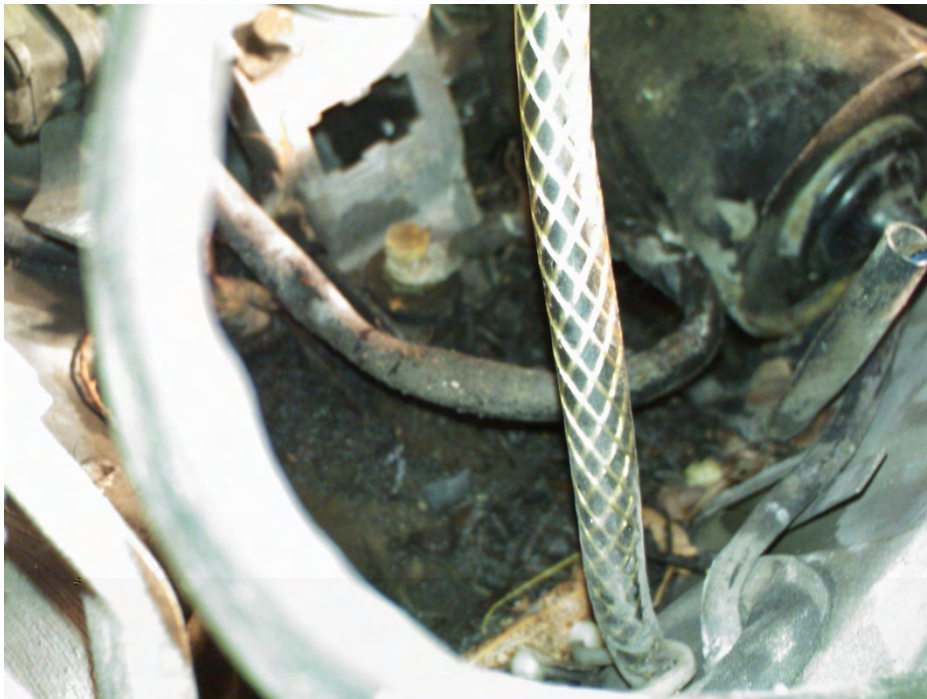
As can be seen in the above photo's, there is some debris, leaves & much under the concentrated washer bottle. This seems to be held on top of the bulkhead by the wires for the wiper motor & others which have sagged or moved with the age of the car & now are sitting on the bulkhead causing a "Dam" effect for anything that may fall in past the plastic weather tray. I took this opportunity to clear all the rubbish in that area and Hoover any residue so the area was spotless.

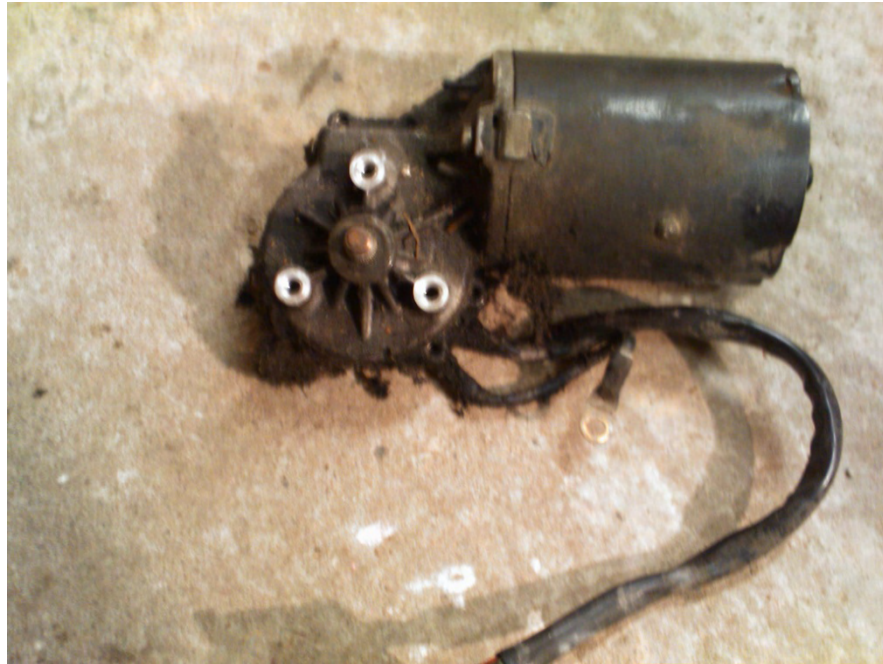
Here is a top view of the motor assembly. [see photo] All outside parts were cleaned and all the debris removed.

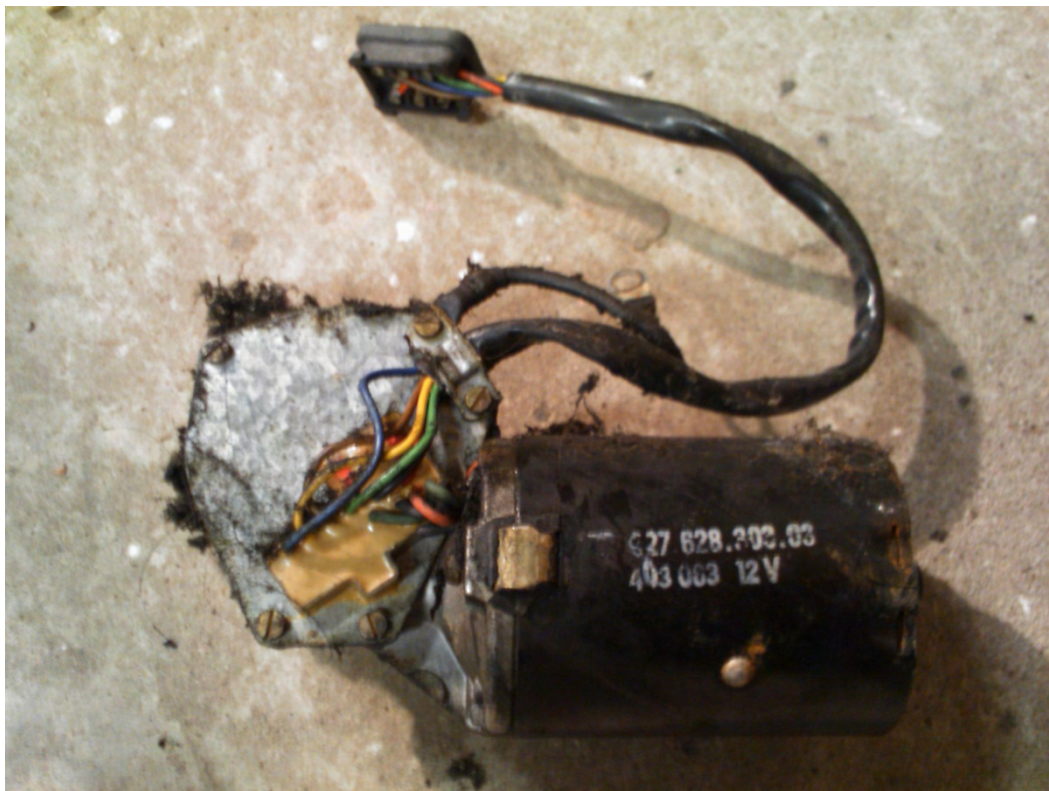
The underside of the motor assembly looks like below. [see photo] I removed the 5 screws and took off the back of the drive housing to reveal the drive mechanism showing the worm drive spindle and concentric circular plastic discs which provide the oscillating motion for the Wiper. These were all nicely still greased up so I left these in situ as they looked like a bitch to put back together & get right.

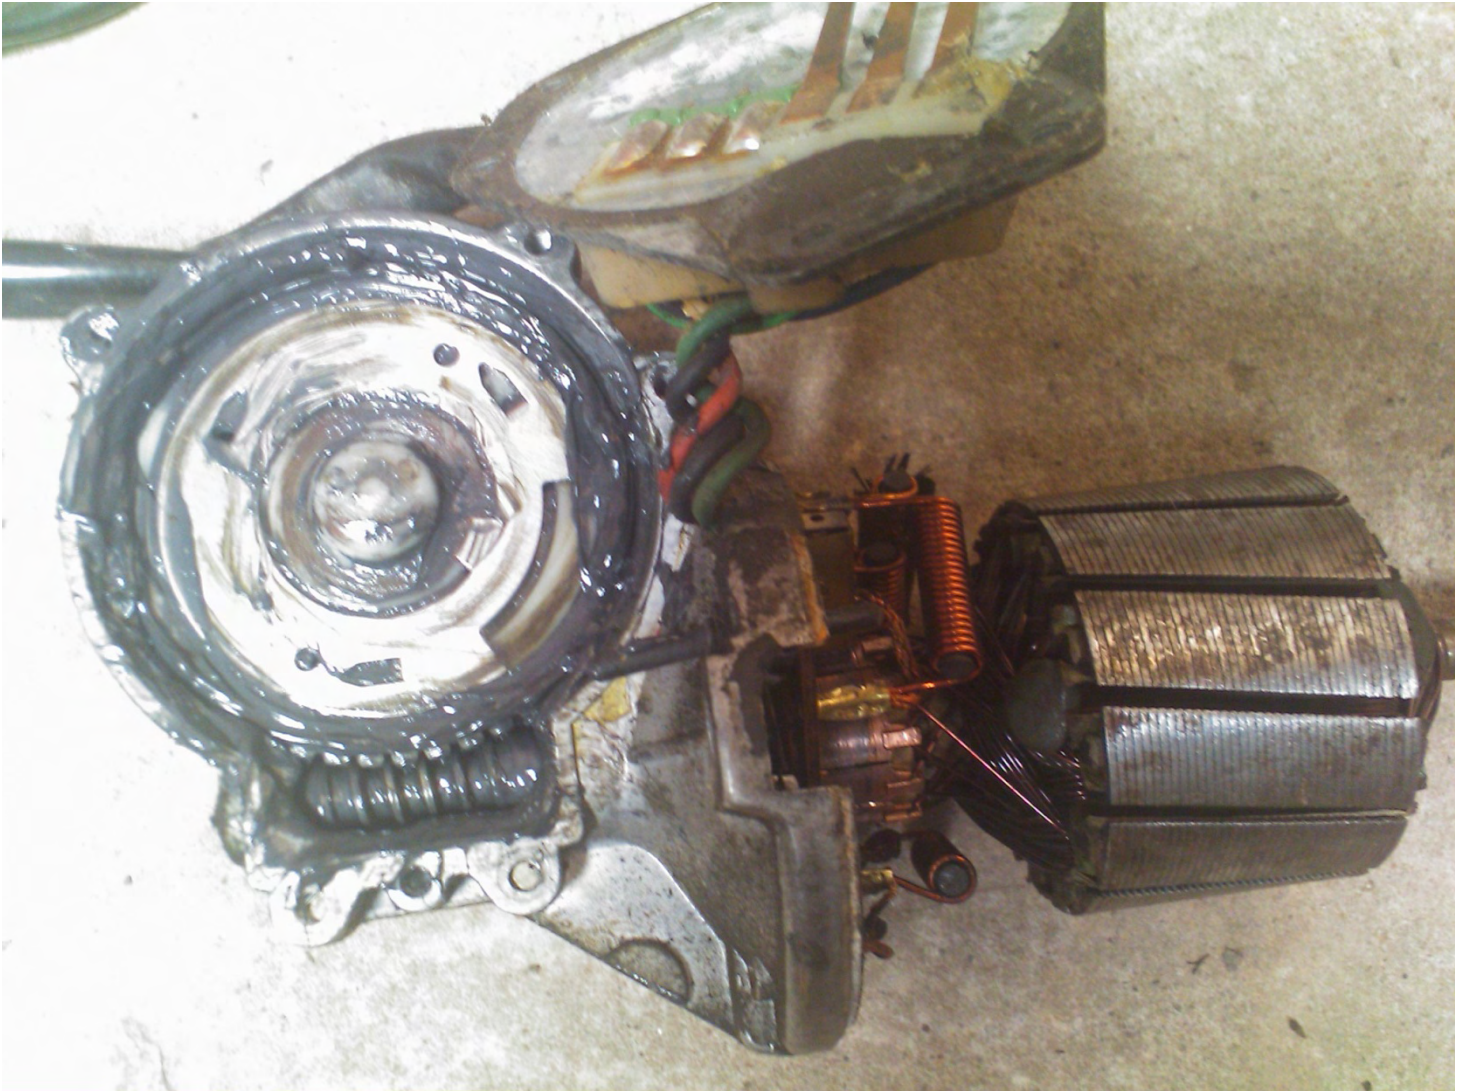
Next, need to remove the field magnet housing. There are two large Phillips screws that hold the Field coil housing to the Alloy cast Drive Mechanism. These need to be removed and the retaining lugs they screw in to, pulled out from either side to allow the housing to be removed. This requires quite a bit of

force as the field magnets are strong & hold on to the armature. Once the housing is removed you are left with the stripped motor shown below – [see photo].

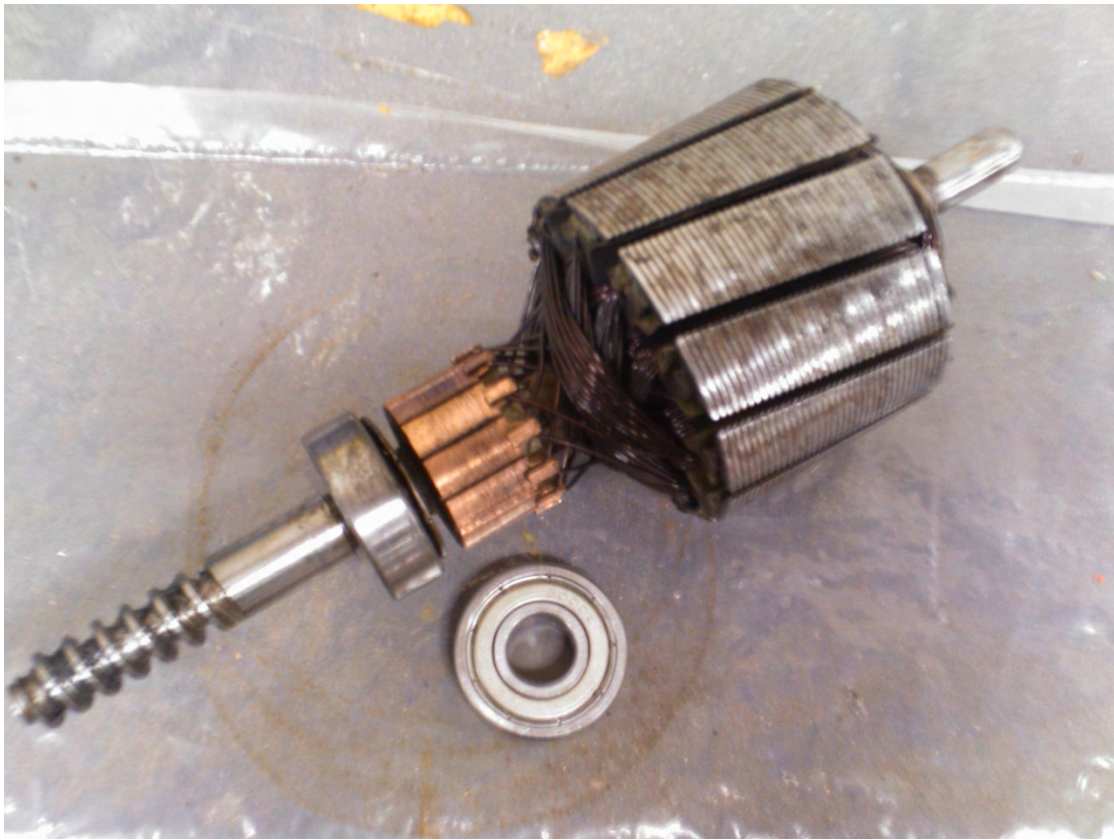
Here you can see the old bearing still on the shaft and the new bearing by the side. This is a very common bearing & very easily available and very cheap at around £3.00. The bearing number is 6000Z

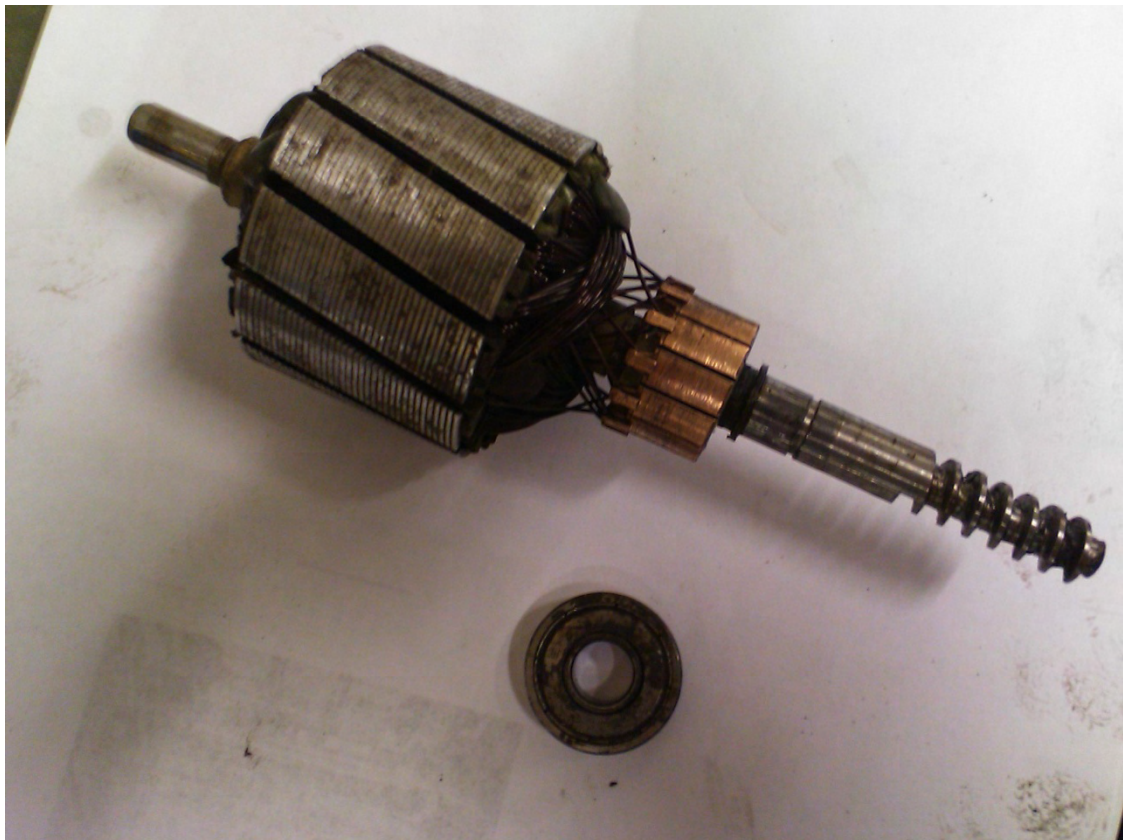
The Bearing now needs to be removed. First remove the circlip from the shaft and get 2 pieces of thin bar which will go in the small 5mm gap in between the bearing and the copper comm. Set these bars across the open jaws of a vice so you can effect a sharp blow with a hammer down on the end of the shaft – being very careful not to damage the end of the spiral worm gear. A few sharp blows & the old bearing is free showing the lower circlip as seen below.

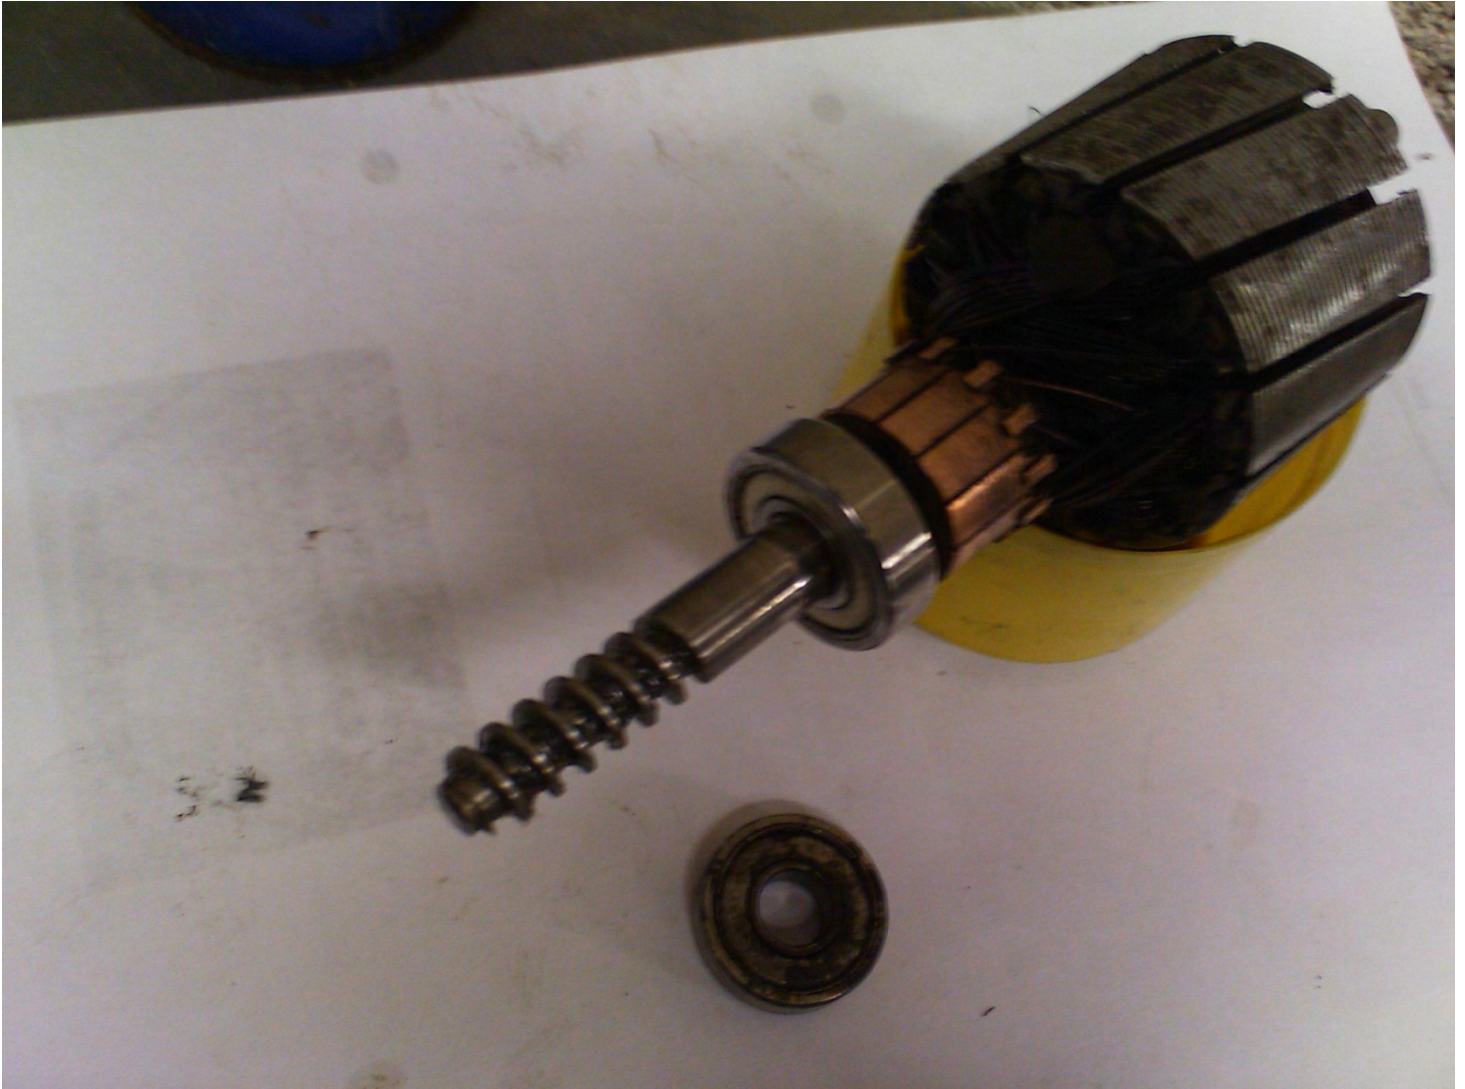
The new bearing is fitted by finding a piece of copper pipe or hard PVC pipe just a bit bigger than the armature spindle diameter but not too large to miss the centre of the new bearing & thus damage the new bearing. Tap firmly in place and refit the 2nd circlip on the top of the bearing to hold it in place. New bearing now fitted with old one at the side. [see photo below]

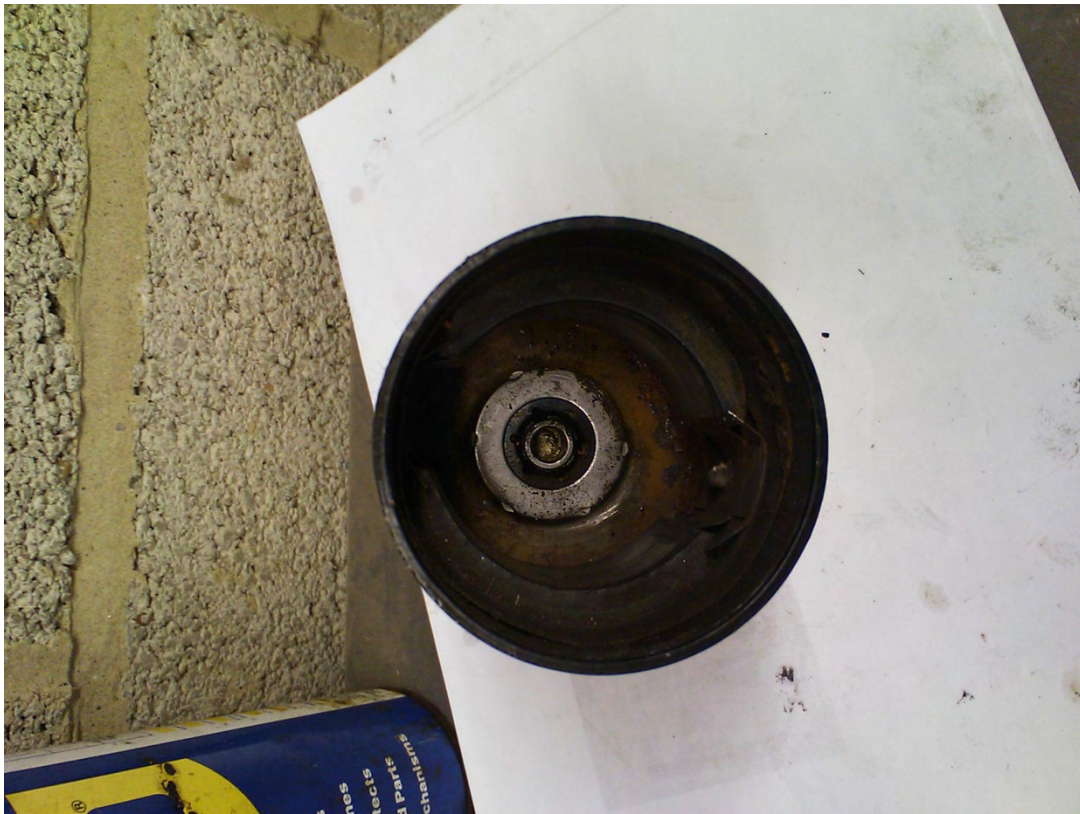
Only thing left to do is clean the inside of the Field magnets & cover. I did this with a flap wheel to make sure there was nothing fouling the gap between the field magnets and the armature. Pay attention to the bearing at the bottom of the cover. [See photo below]

This bearing is a single ball in a clasp. It rotates so once you have cleaned any rubbish from around it you have to make sure it is centred so it will take the shaft at the base of the armature on re-assembly.

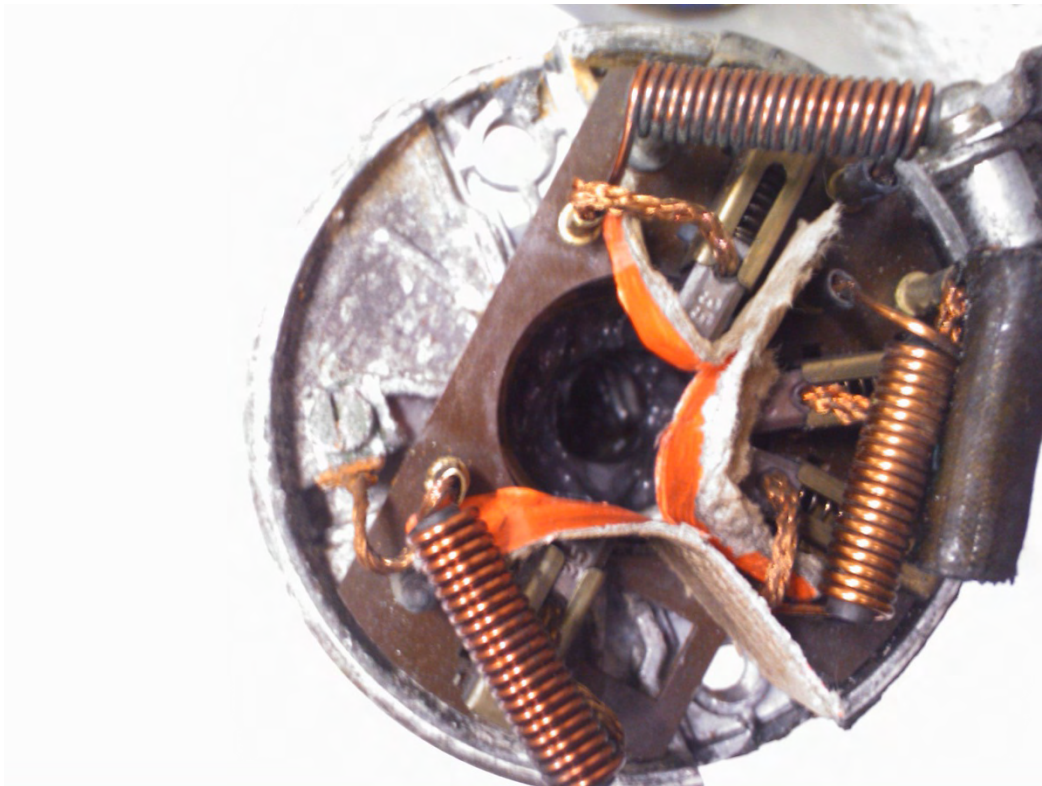
First, cut some thin card strips, about 6mm wide and 40mm long, 3 in all. You will need these to trap the bushes back in their sliding guides to keep their springs & the bushes themselves in place. [See photo]

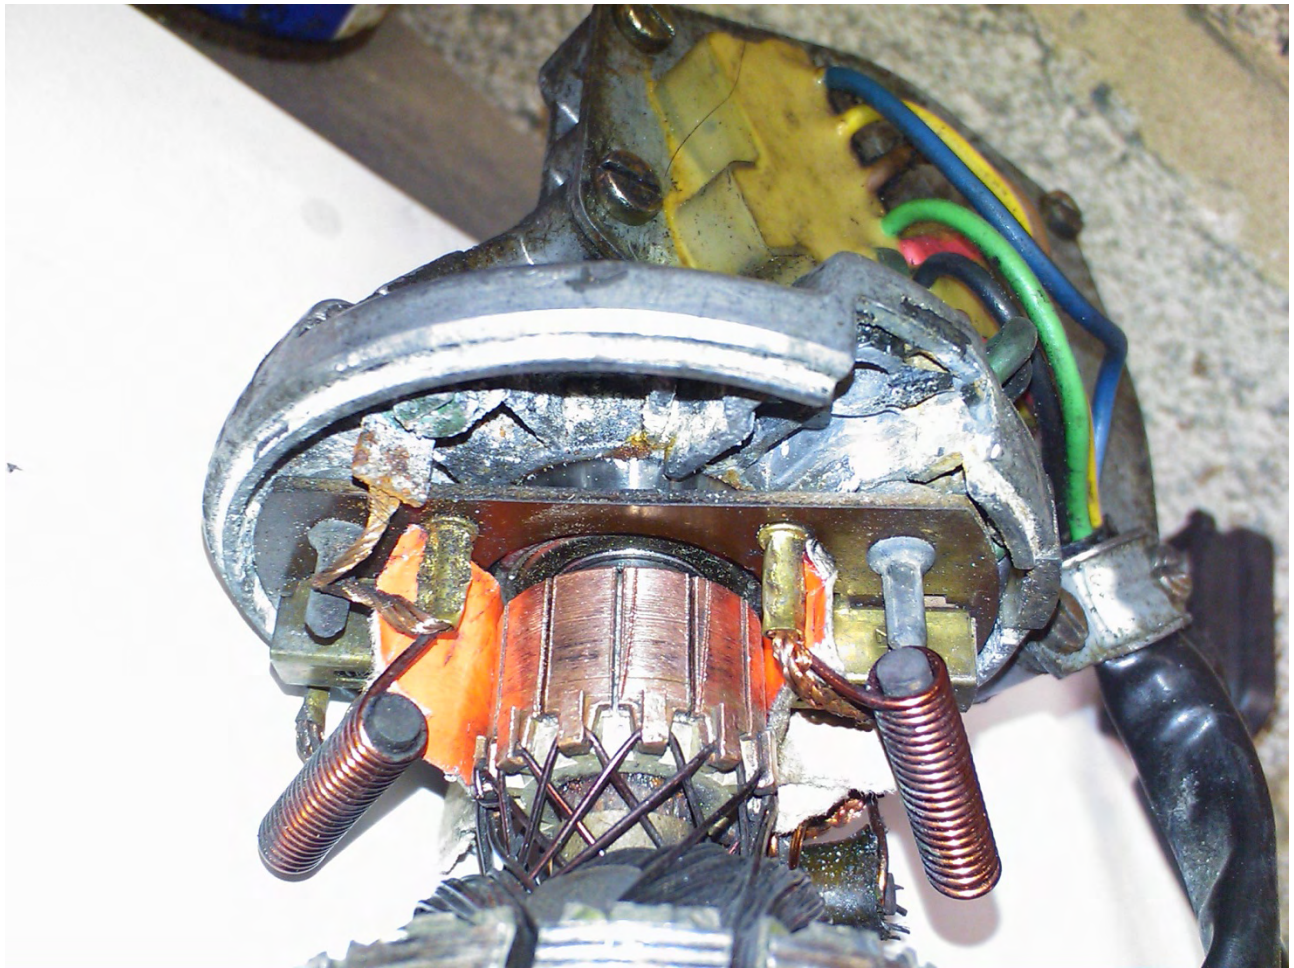
With the cards in place you can then guide the armature back into the drive mechanism assembly until the new bearing is just up to the cards. You will have to turn the armature clockwise as you do this as the worm gear engages with the drive wheels in the housing. Then, Carefully guide the bearing past the carbon brushes pushing the cards outwards to clear the bearing each in turn. Then push the bearing gently into the housing, still rotating clockwise as you go. [See photo below]

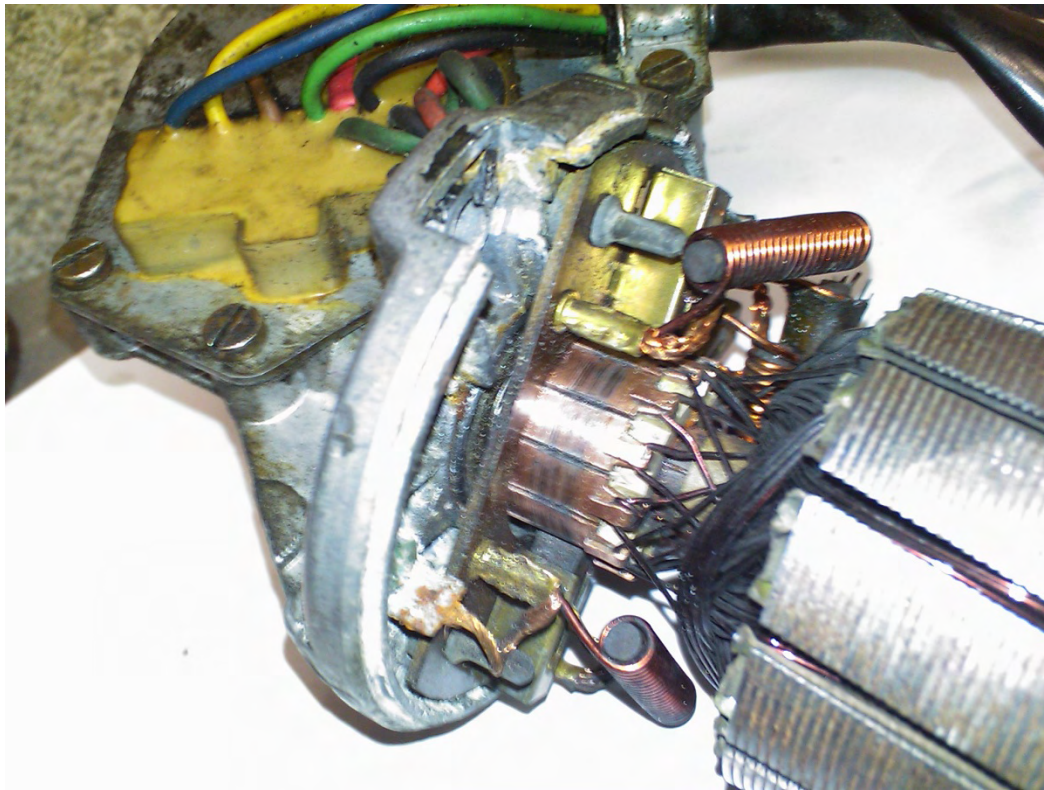
Once the bearing is firmly seated and the worm gear is correctly engaged with the drive mechanism assembly. Rotate the armature shaft to ensure good seating & everything feels ok. Then you can carefully remove the pieces of card which are holding back the 4 carbon brushes. Once removed, rotate the armature again to ensure free running movement & worm drive engages correctly with the drive mechanism. [see photo below]

****Tip**** Make sure as you insert the armature & assembly back into the field magnets that you place a suitable screw driver under the casting & all the way to the centre shaft behind the bearing – this is where the locating lugs fit in the to screw the motor housing together – see photo above in 12:00 position - this stops the bearing coming back out & catching the brushes when you place the armature back into the field magnets & housing. The magnets are very strong & “suck/pull” the whole unit in to the housing pulling the armature shaft & bearing back out of the drive linkage housing if you’re not careful!

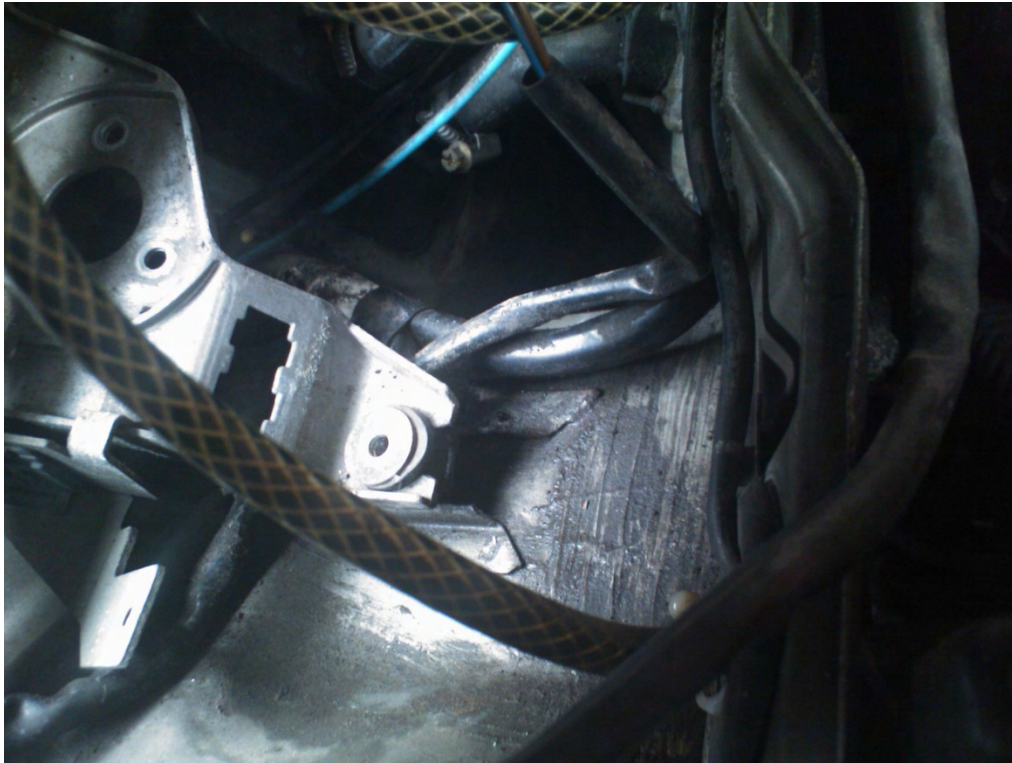
Now the motor is done, make sure you clean all the debris & rubbish that had collected at the top of the bulkhead & under the concentrated washer bottle. Cleaning up the bulkhead around the support bracket for the wiper motor and it can be clearly seen why this problem happens - The large wire going to the Central HVAC box passes underneath the Wiper Motor and effectively causes a dam for all the debris and water. Potential disaster area! [See Photo below]

Note the position of the wiring harness. This is what causes the rubbish to collect in the first place and fills the area under the motor with water when it rains thus flooding your motor & causing this disaster. Once I re-fitted the motor into the bulkhead I put a cable-tie around the motor housing & positioned the wiring harness so it wasn't resting on the bulkhead floor anymore. Now water can run down into the bulkhead freely should it have to and escape via that ominous little rubber flap that is often talked about on the passenger side of the bulkhead & engine compartment
